Report

Project: Waddenzee – 1st LiDAR
acquisition for 2018

Name: Waddenzee – 1st LiDAR acquisition for 2018
Number: 40958 / 25535
Area: Pinkegat and Zoutkamperlaag in the Wadden Sea, in the north of the Netherlands

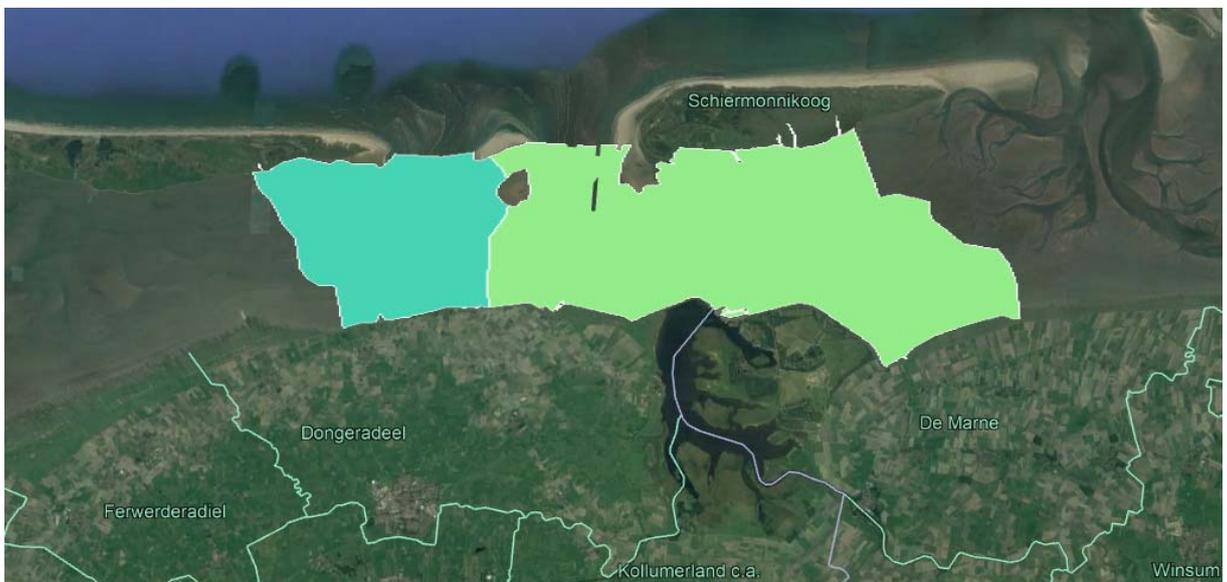
Figure 1: Project area Waddenzee

The figure below shows the location of coverage the 2 areas in the Waddenzee project.

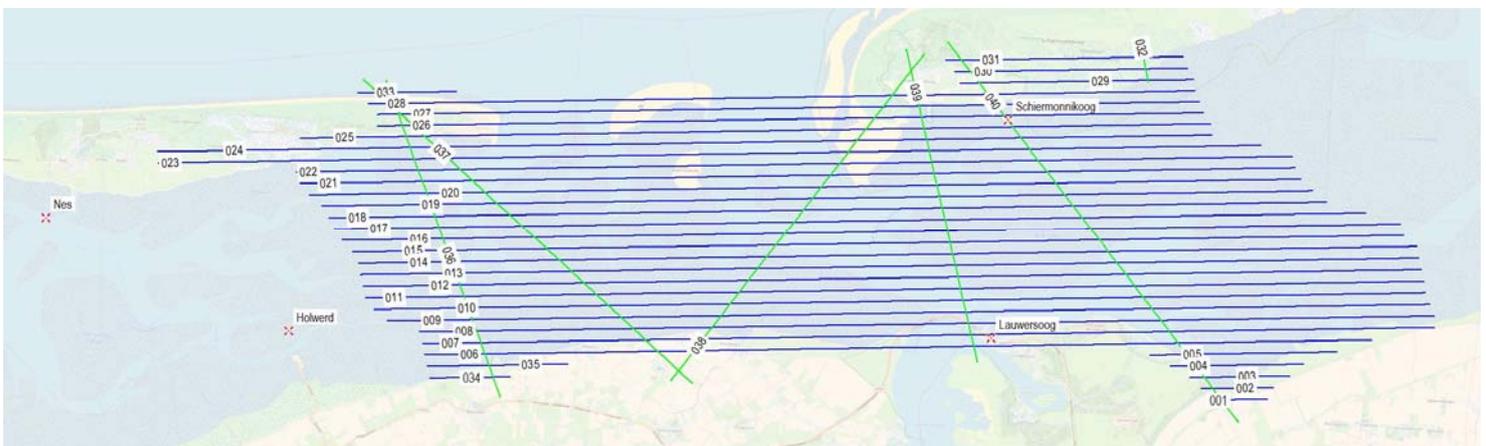
Figure 4: Flightplan and waterlevel stations

Project lines are represented in blue, while crossing lines are drawn in green. Water level stations are marked with red crosses:

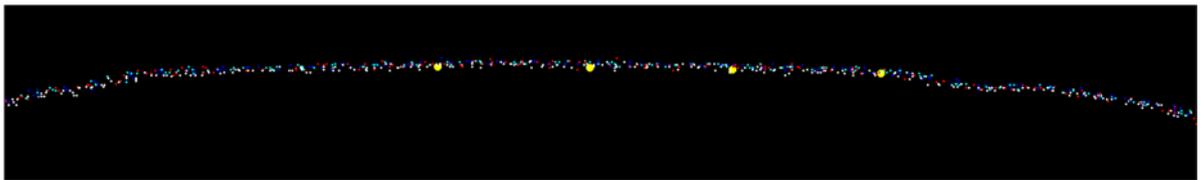
Figure 9: Control surfaces (yellow) after adjusting laserdat +10 mm. The different colors represent different flightlines

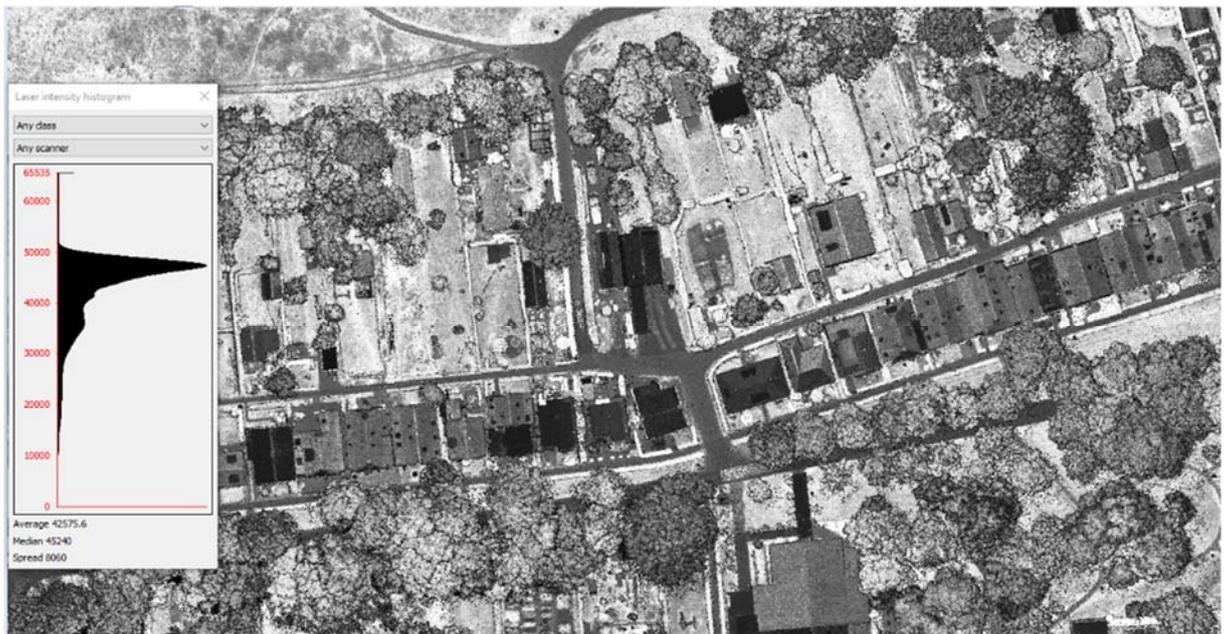
Figure 10: Image shows intensity values in top view with histogram

Reflectance – A target property. Refers to the optical power that is reflected by that target at a certain wavelength. RIEGL's V-Line instruments provide a reflectance reading for each detected target as an additional attribute. The reflectance provided is a ratio of the actual, optical amplitude of that target to the amplitude of a diffuse white flat target at the same range reading is given in decibel (dB). Negative values indicate diffusely reflecting targets, whereas positive values are usually retro-reflecting targets. Reflectance is distance independent, thus is a perfect attribute for many different classifications and further processing.

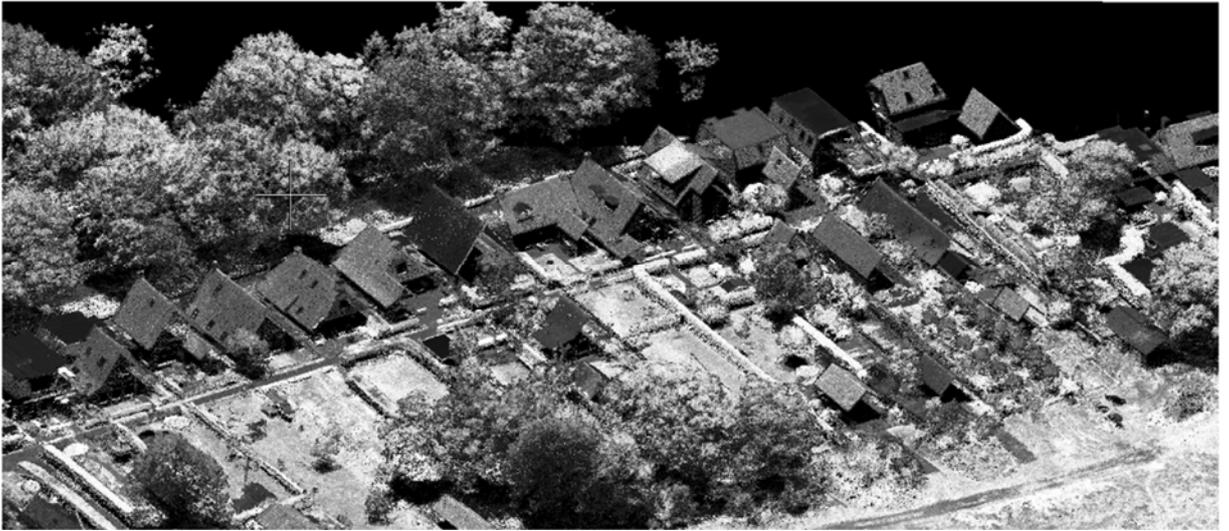
Figure 11: Image shows intensity in cross section / 3D view

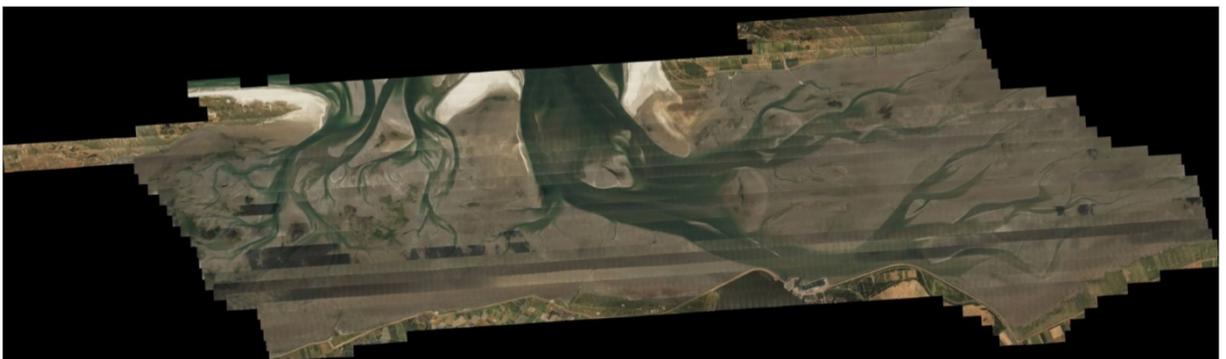
Figure 15: Mosaic of project after all corrections except Multiframe color balancing

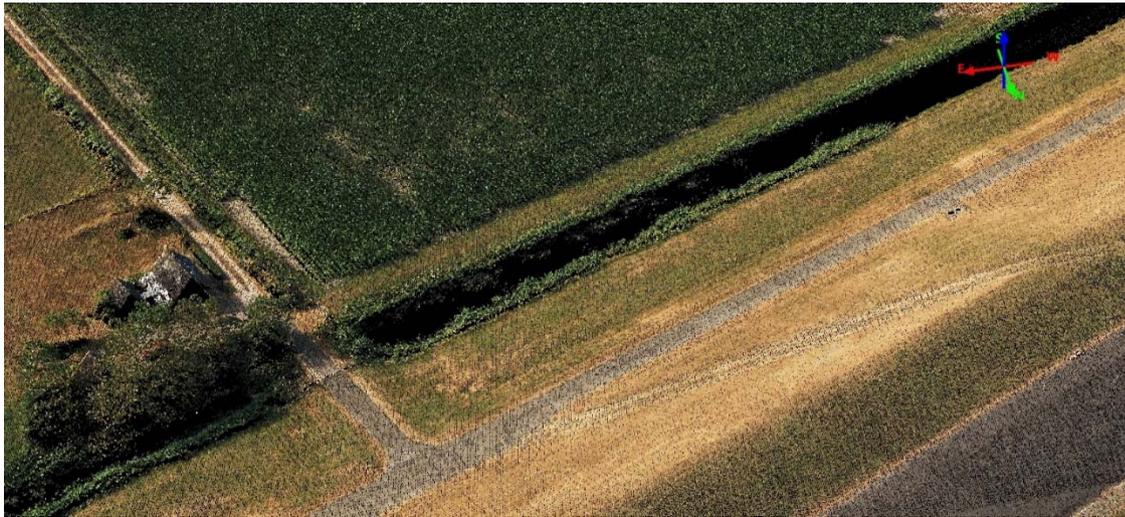
Figure 17: RGB colored pointcloud

The points in the classified point cloud have been assigned color values from the generated orthophoto of the simultaneously captured vertical images of the area. In order to match the point density in the LIDAR-data, image data has been downsampled from original GSD 2cm (2500 pixels per m²) to GSD 10cm (100 pixels per m²).

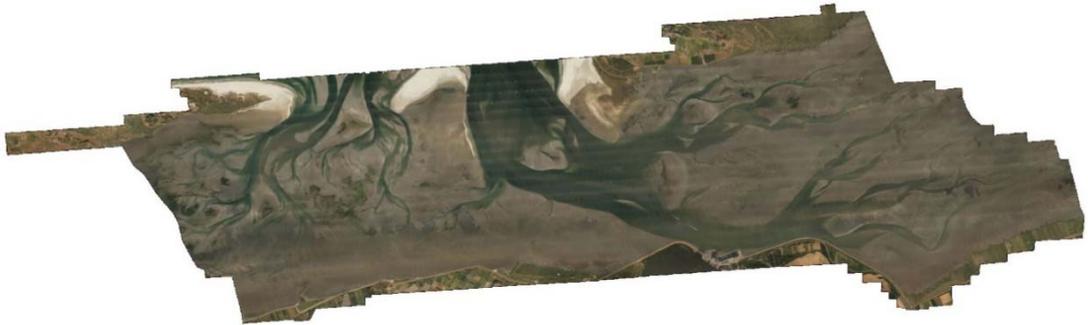
Figure 20: Orthomosaic – images after GlobalTilting adjustment

Further radiometric adjustment between overlapping images was performed in connection with the mosaic processing in OrthoVista with the feature "Global tilting adjustment" option. This feature observes differences in intensity, contrast and color between overlapping images / flightlines and calculates relative corrections that compensate for the differences.
